# NAVAL POSTGRADUATE SCHOOL

## THESIS

**DYNAMIC FAILURE OF SANDWICH BEAMS WITH FLUID-  
STRUCTURE INTERACTION UNDER IMPACT LOADING**

December 2010

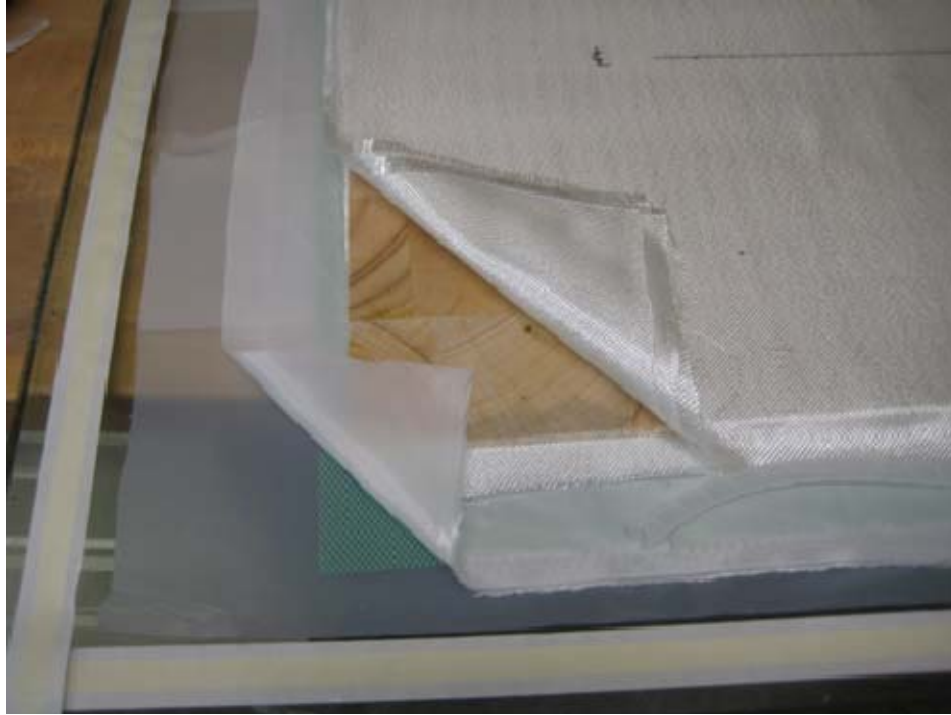
Step 4: Layup material in the following order from bottom to top: distribution medium (required on mold side since skin thickness limits resin flow), peel ply, 3 sheets of E-glass, fibers aligned, balsa core, 3 sheets of E-glass, peel ply, distribution medium, peel ply (to protect the vacuum film from the cut edges of the distribution medium.) Figure 2 shows the beginning of this layup sequence.

Figure 2. Dry layup, bottom to top: Teflon, distribution medium, peel ply, E-glass, Balsa Core, E-glass. Not yet added: peel ply, distribution medium, vacuum film.

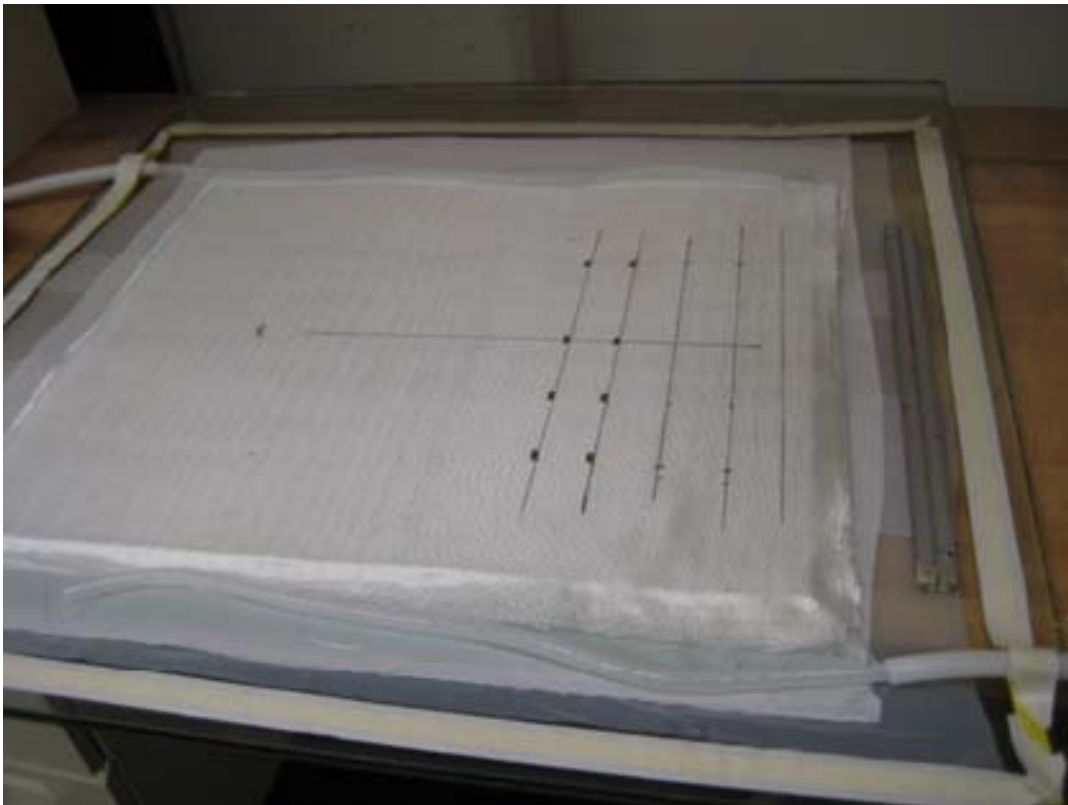
Strain gages were placed at mid span, quarter span, eighth span, and on the free side of the clamped support boundary as depicted in Figures 4 and 5.

Figure 5. Strain gage placement on dry layup

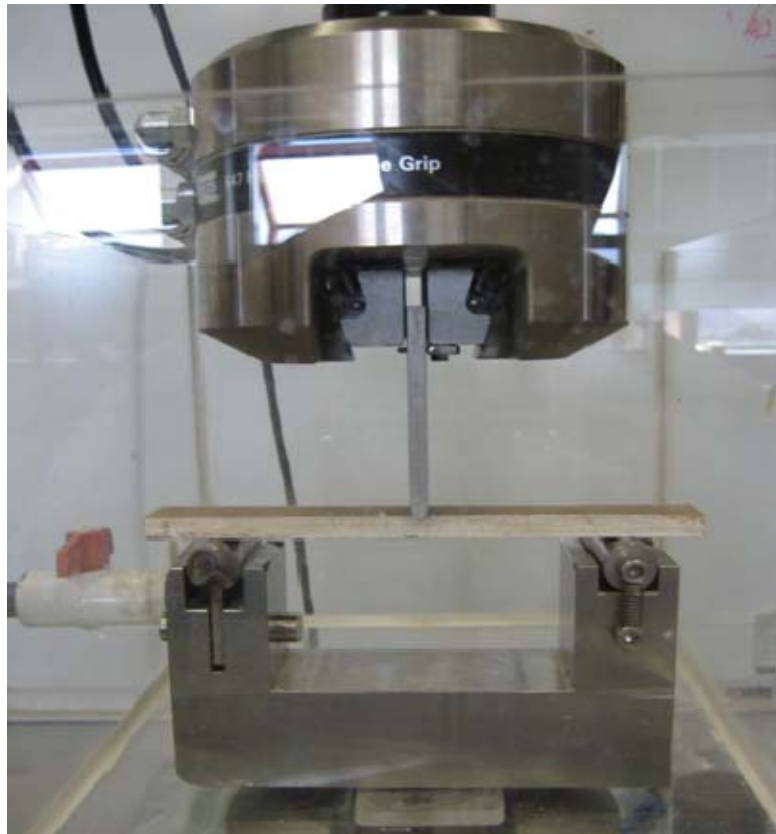
This stainless steel fixture was constructed in the NPS machine shop with a span of 152.4 mm (6 in) and a depth of 50.8 mm (2 in) to conduct testing in accordance with ASTM D 709 [17]. The fixture was attached to the hydraulic grips via a squared stud threaded into a hole tapped in the center of the bottom of the fixture. The 50.8 mm (2 in) wide center point is composed of 6.35 (0.25 in) mm aluminum stock with a radius milled along the contact edge. Figure 6 shows the fixture with coupon in place in the submersion tank.

Figure 6. Three-point bending fixture

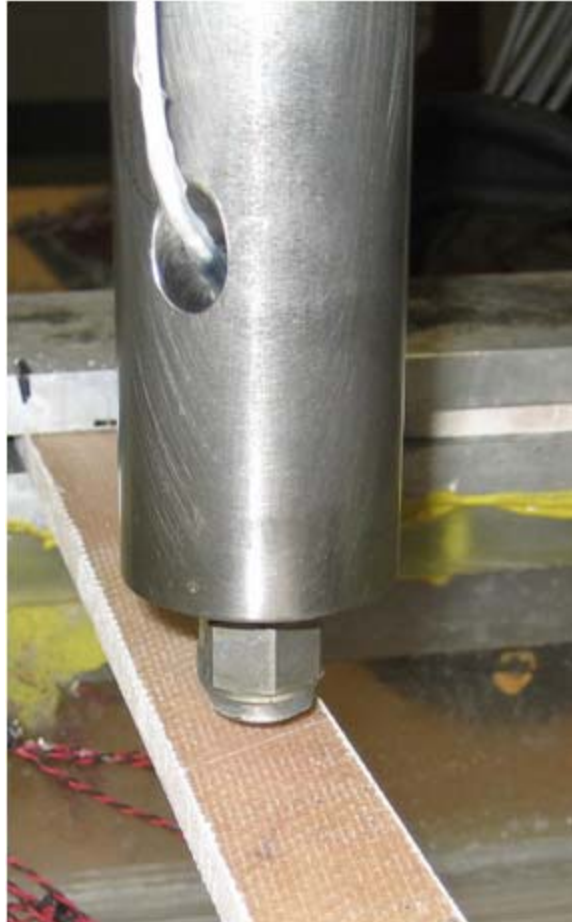
The load cell was an ICP® force sensor manufactured by PCB Piezotronics, Inc., which converts force into a measurable electrical output. The load transducer was mounted on the end of the impactor rod, as shown in Figure 7. The gage had a diameter of 16mm. In order to increase longevity in an aqueous environment, both the gage and cable connection were coated with M coat A bond. Additional waterproofing was provided by a thin latex sleeve fitted over the end of the impacting rod.

Figure 7. Piezo electric load cell
